Research paper

Prefeasibility of the installation of tourist services in the laguna de pampahuasi protected reserve, town center of lliupapuquio, district of San Jeronimo, province of Andahuaylas, Perú

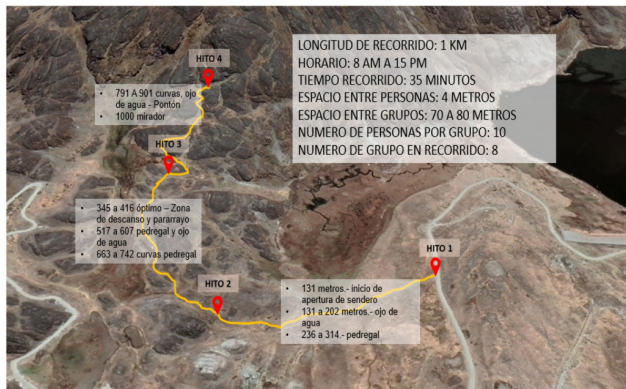
Figure 16: Trail Sectioning

Note: In this image, the distances in meters of the route are detailed, as well as the number of people per group and the space between groups to better manage the recreational activity. Own elaboration.

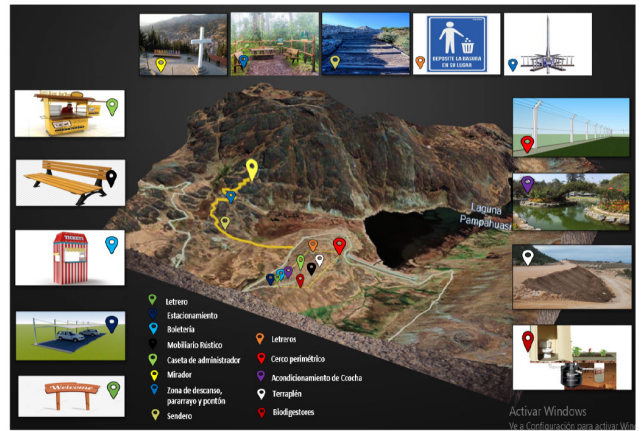
Figure 3: Summary of Projected Activities and Tourist Facilities

Note: The image shows the location of each of the facilities that will be implemented to improve the tourist service. Own elaboration.

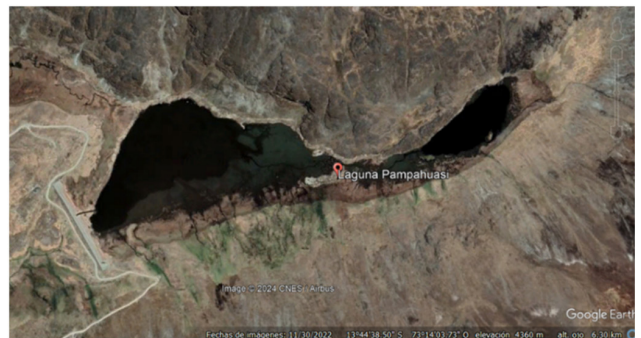
Figure 4: Satellite view of the project intervention in Pampahuasi lagoon

Note: The approximate satellite coordinates, where the lagoon is located with UTM data: 13°44'55.01" south and 73°14'05.81" west at an altitude of 4,216msnm. Own elaboration
